## BUILDING INSPECTION REPORT

# 42 Queen Street, Ponsonby, Auckland 1011

Thursday, March 26, 2026

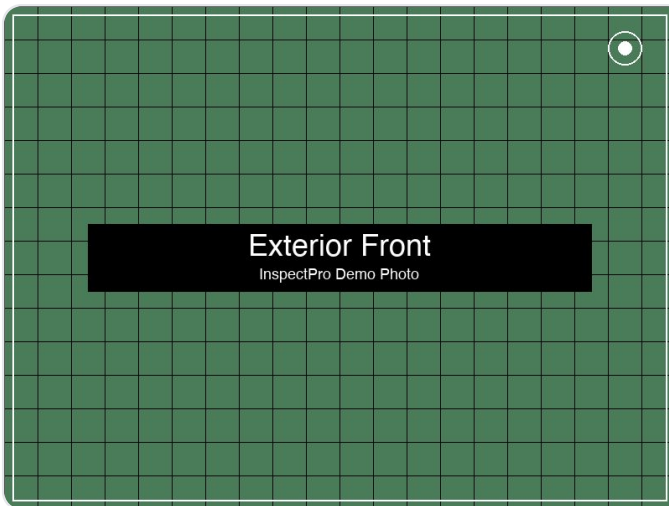
Photo 1

MINOR

South wall — paint peeling near downpipe

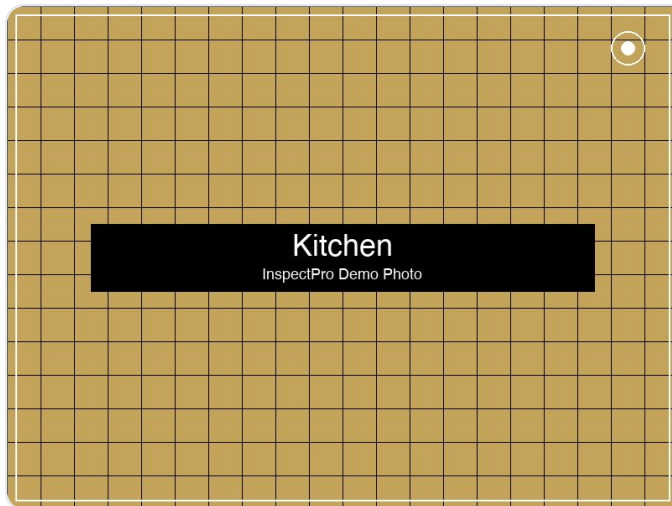
### Photo 1

Kitchen overview — recent renovation

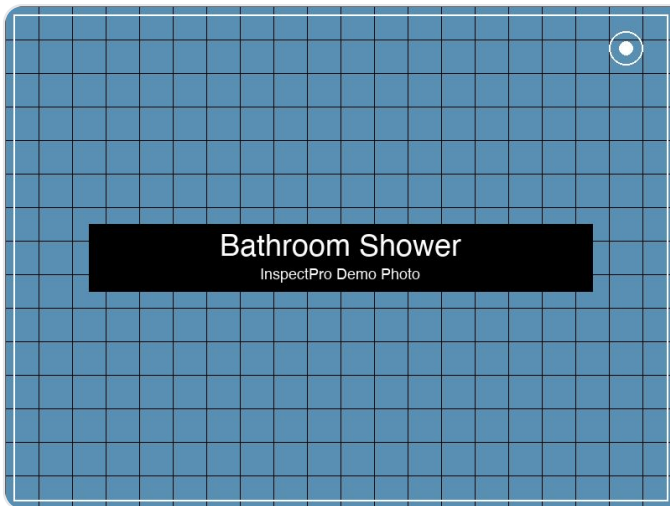
### Photo 1

MODERATE

Shower sealant — early mould visible

Silicone sealant around shower shows early signs of mould. Recommend resealing within 6 months. Exhaust fan operational.

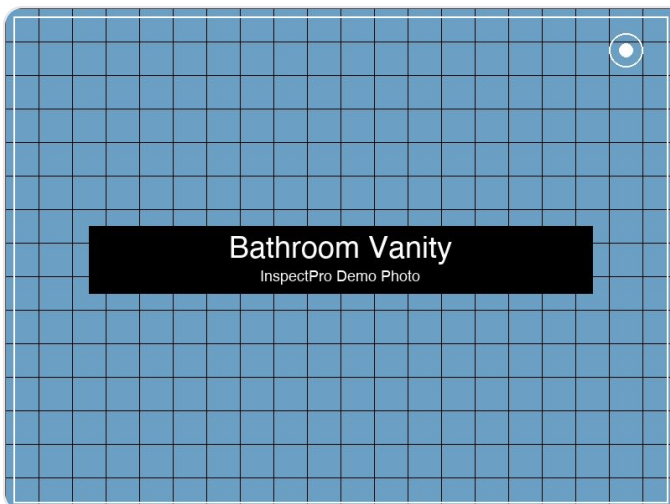
### Photo 2

Vanity and basin — good condition

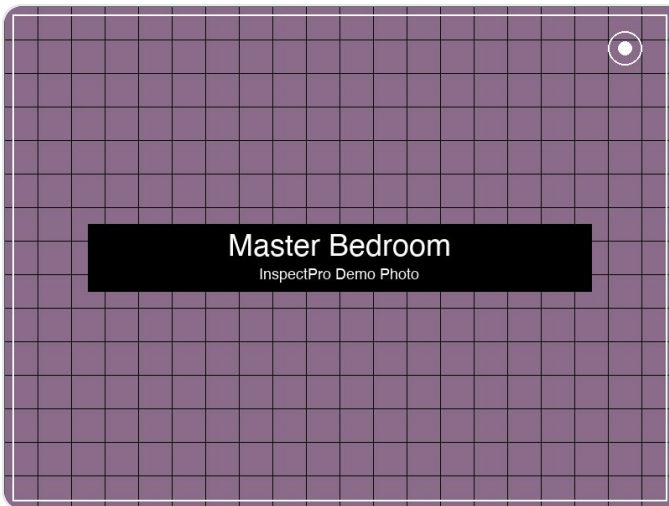
### Photo 1

Bedroom overview — normal wear
